## 15A4SS125DB

## Square Direct Burial Aluminum Light Pole 15 Foot Above Grade, 4 Inch Wide, 0.125 Inch Wall Thickness

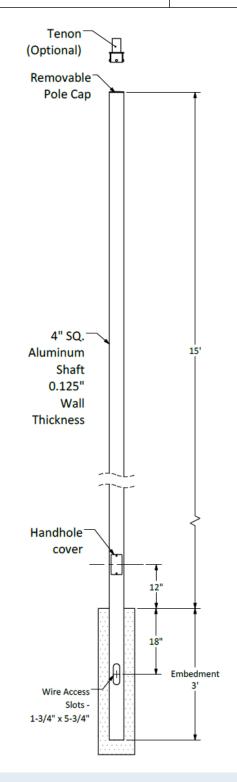
**Pole Shaft:** 15 ft. height above ground, 4 in. square straight aluminum with 0.125 in. wall thickness. The pole shaft is constructed of seamless extruded tube of 6063 Series Aluminum Alloy per the requirements of ASTM B221.

**Handhole:** 2 in. X 4 in. handhole is located 12 in. above ground. Handhole cover with 2 screws is provided. A ground lug with set screw is located near the handhole opening for proper grounding of the pole.

Embedment: Embedment length is 3 ft. Wire access is provided 18 in. below ground line.
